North End

Center Rutland (Mead) Falls

RUTLAND REGIONAL PLANNING COMMISSION

South End

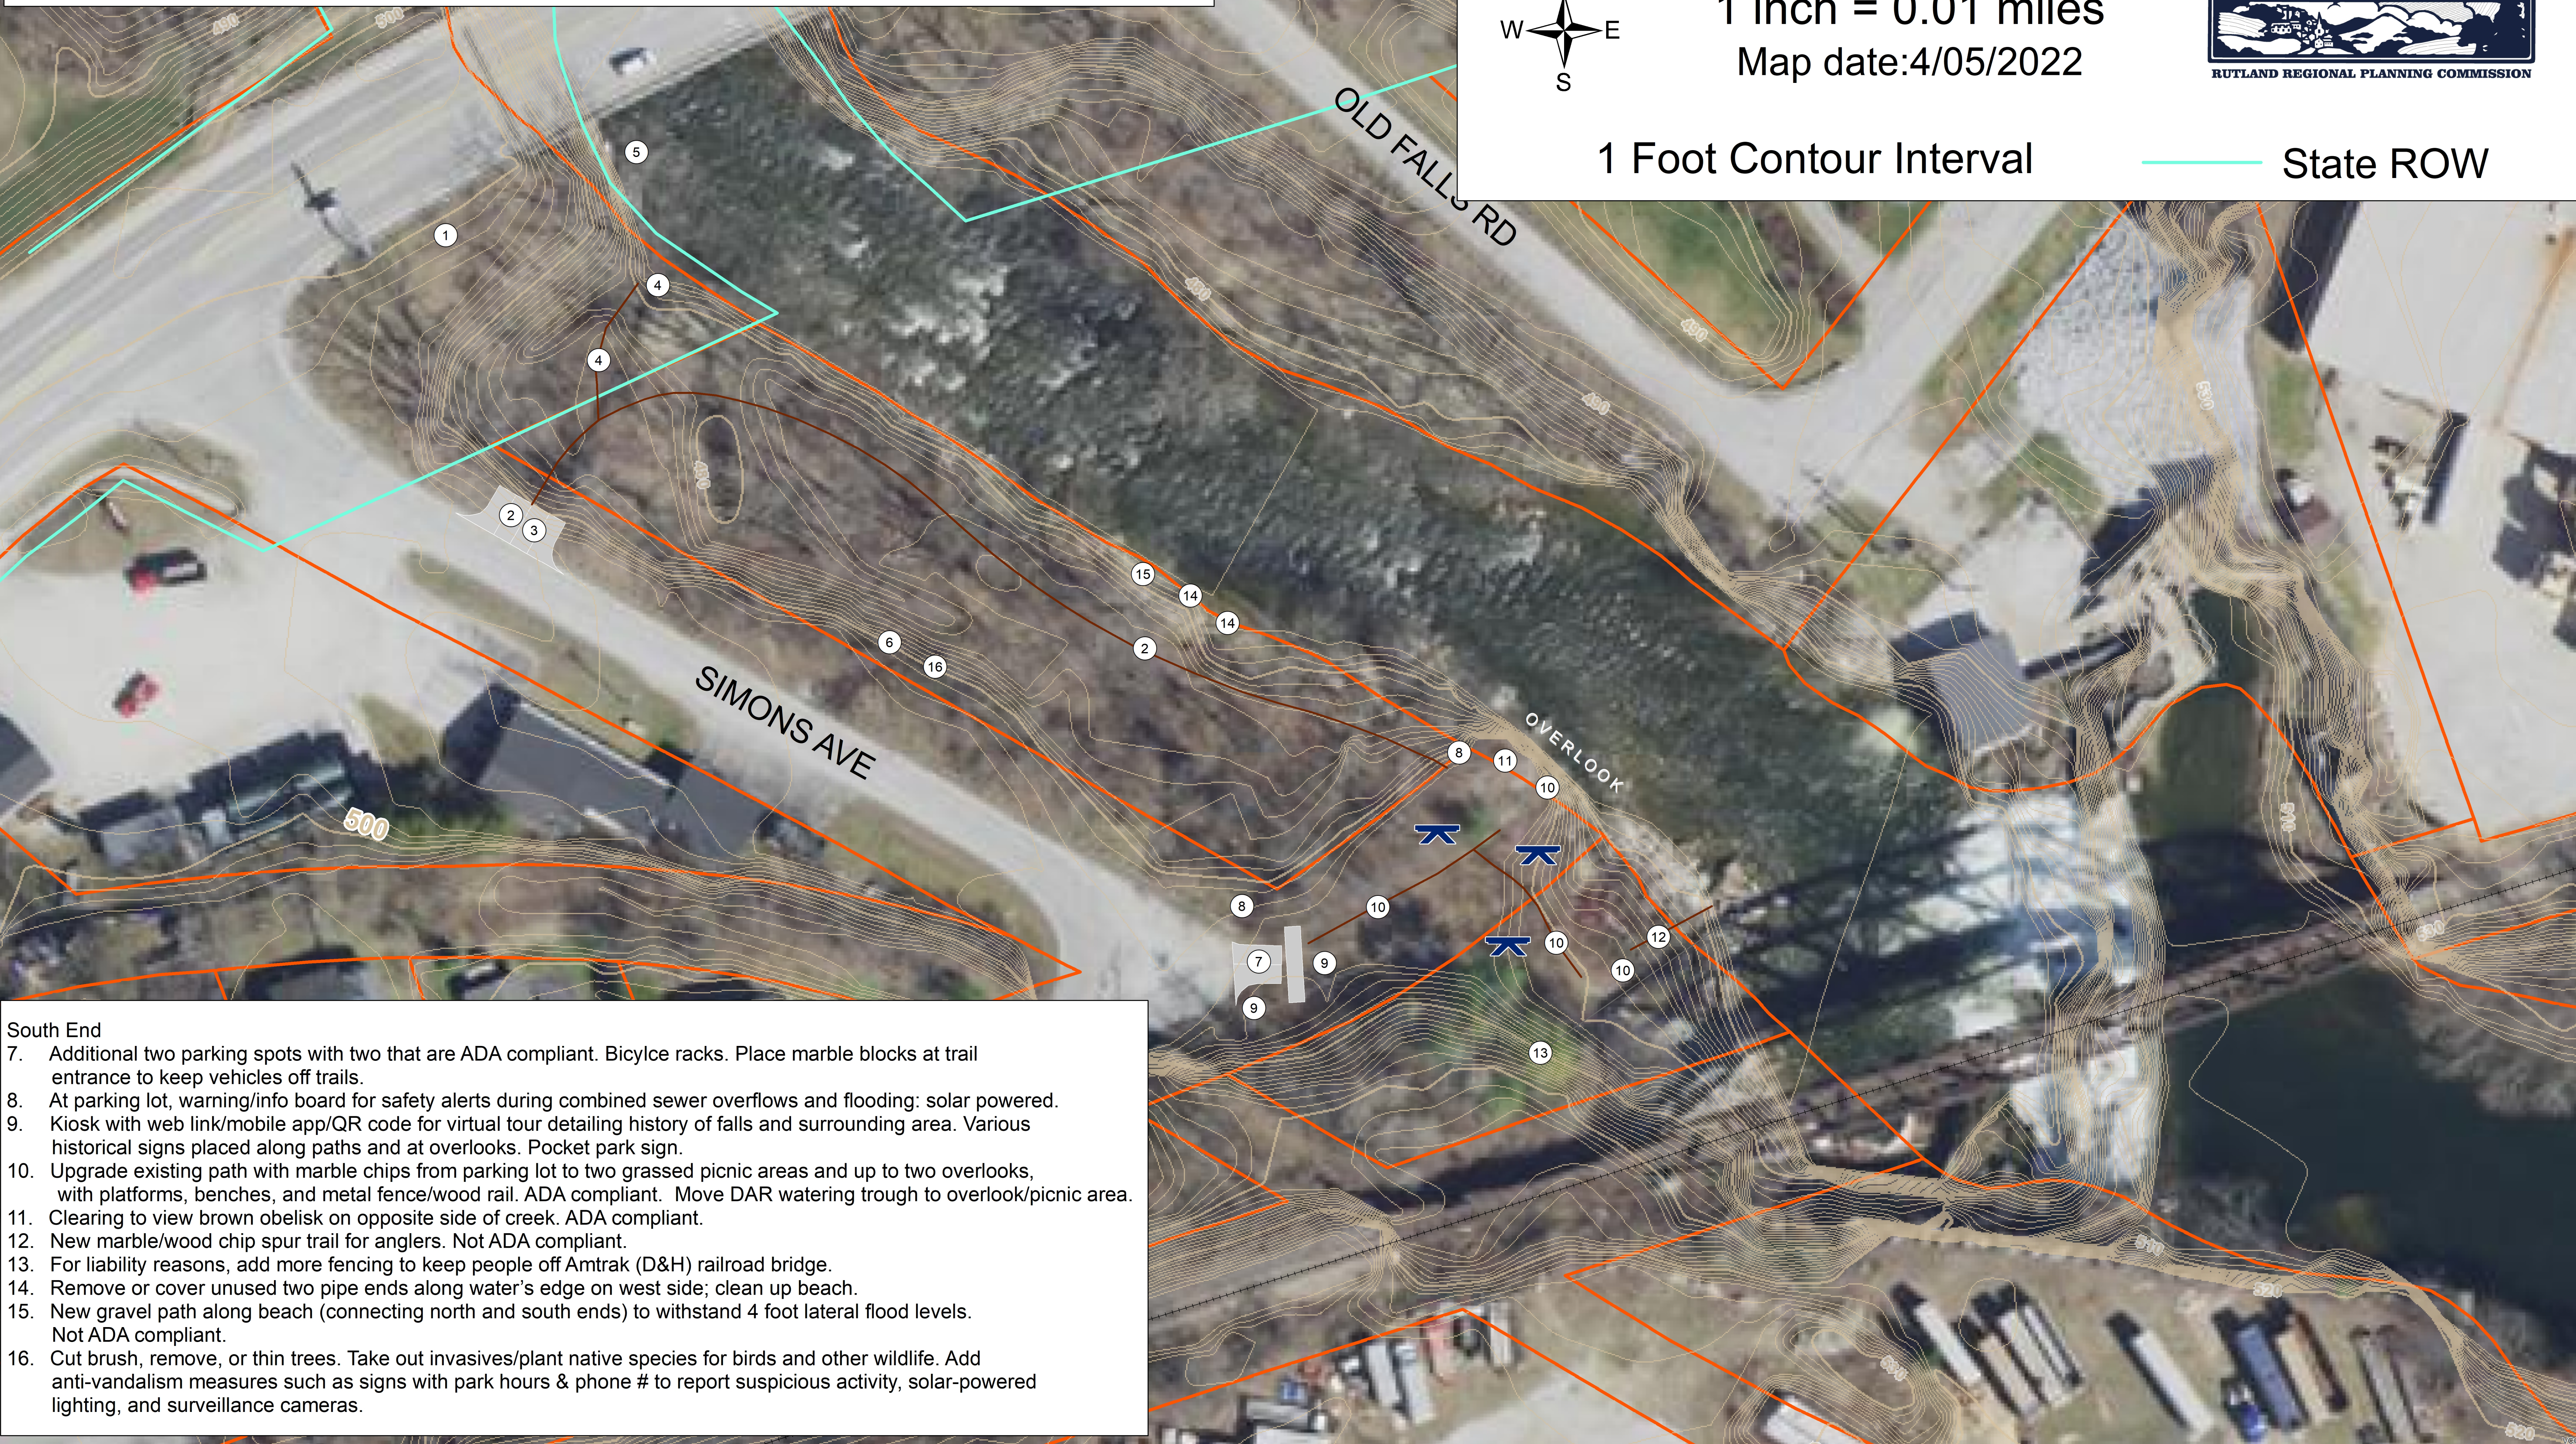
1. Buff up Meads Falls historical marker; add a new sign for the pocket park. (State ROW restrictions?)
2. New parking lot off Simons Ave – four spots (two ADA compliant). Bicycle racks. Link parking to new gravel/wood or marble chip path that connects with overlook/picnic area on south end.
3. At parking lot, warning/info board for safety alerts during combined sewer overflows and flooding: solar-powered.
4. Canoe/kayak launch and new spur trail (marble/wood chips and wood/marble chip steps) off new main trail. Not ADA compliant.
5. Remove trees in creek (State Stream Alteration Permit?)
6. Cut brush, remove, or thin trees along Simons Ave. (across from Johnson Energy). Take out invasives/plant native species for birds and other wildlife. Add anti-vandalism measures such as signs with park hours & phone # to report suspicious activity, solar-powered lighting, and surveillance cameras.

7. Additional two parking spots with two that are ADA compliant. Bicycle racks. Place marble blocks at trail entrance to keep vehicles off trails.
8. At parking lot, warning/info board for safety alerts during combined sewer overflows and flooding: solar powered.

9. Kiosk with web link/mobile app/QR code for virtual tour detailing history of falls and surrounding area. Various historical signs placed along paths and at overlooks. Pocket park sign.

10. Upgrade existing path with marble chips from parking lot to two grassed picnic areas and up to two overlooks, with platforms, benches, and metal fence/wood rail. ADA compliant. Move DAR watering trough to overlook/picnic area.

11. Clearing to view brown obelisk on opposite side of creek. ADA compliant.
12. New marble/wood chip spur trail for anglers. Not ADA compliant.
13. For liability reasons, add more fencing to keep people off Amtrak (D&H) railroad bridge.

14. Remove or cover unused two pipe ends along water's edge on west side; clean up beach.
15. New gravel path along beach (connecting north and south ends) to withstand 4 foot lateral flood levels. Not ADA compliant.

16. Cut brush, remove, or thin trees. Take out invasives/plant native species for birds and other wildlife. Add anti-vandalism measures such as signs with park hours & phone # to report suspicious activity, solar-powered lighting, and surveillance cameras.
